**MARINE OCCURRENCE REPORT**  
**M99C0016**

**BOTTOM CONTACT**

**PASSENGER VESSEL "CANADIAN EMPRESS"**  
**LAKE SAINT-LOUIS, QUEBEC**  
**13 MAY 1999**

Report Number M99C0016

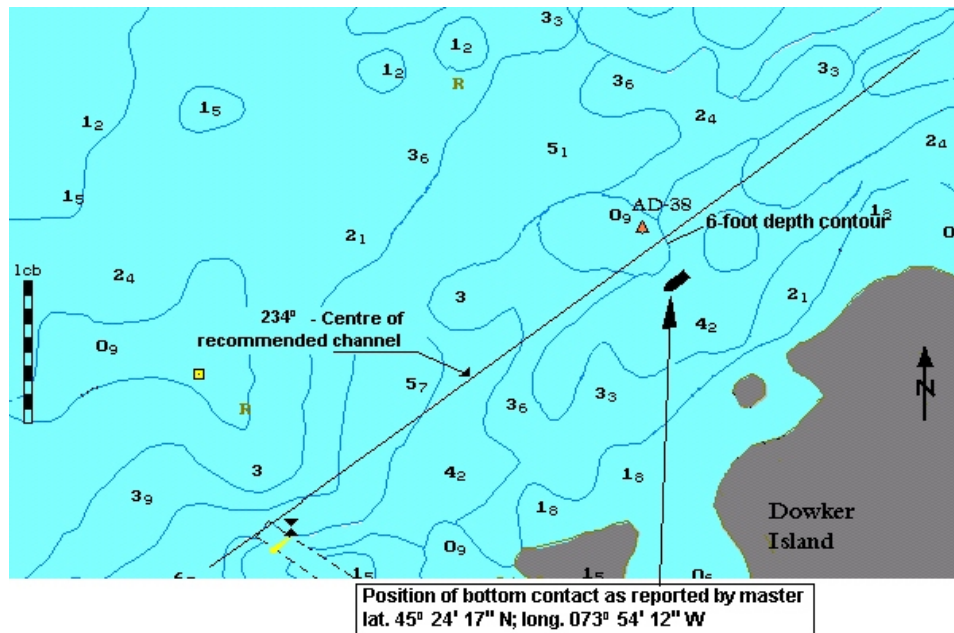
Figure 1

Although the master thought that he had correctly pushed the "man overboard" button on the DGPS to mark the position of the incident, no position was recorded. The master declared that he possibly did not hold the "man overboard" button down long enough for the function to register. Two days after the incident, the master reported the occurrence position to the Coast Guard Radio Station as latitude 45°24'17" N, longitude 073°54'12" W (see Figure 1) but qualified this position as "approximate" due to the numerous tasks and distractions immediately after the incident.

Both the master and mate had extensive experience in these waters, but they had never navigated in that area with water levels so low. The predetermined distances used successfully in the past by the master for passing up Lynch Channel and past buoy AD-38 have the vessel crossing the tip of a 1.83-m (6-foot) depth contour that overlaps the centre of the recommended channel, as seen in figures 1 and 2. In the past, with water levels consistently 0.9 m to 1.2 m (3 to 4 feet) above chart datum, this was not a problem. On this voyage, with the water level only 0.28 m (11 inches) above chart datum, the intended course brought the vessel in proximity to water depths of less than 2.10 m (6.9 feet).

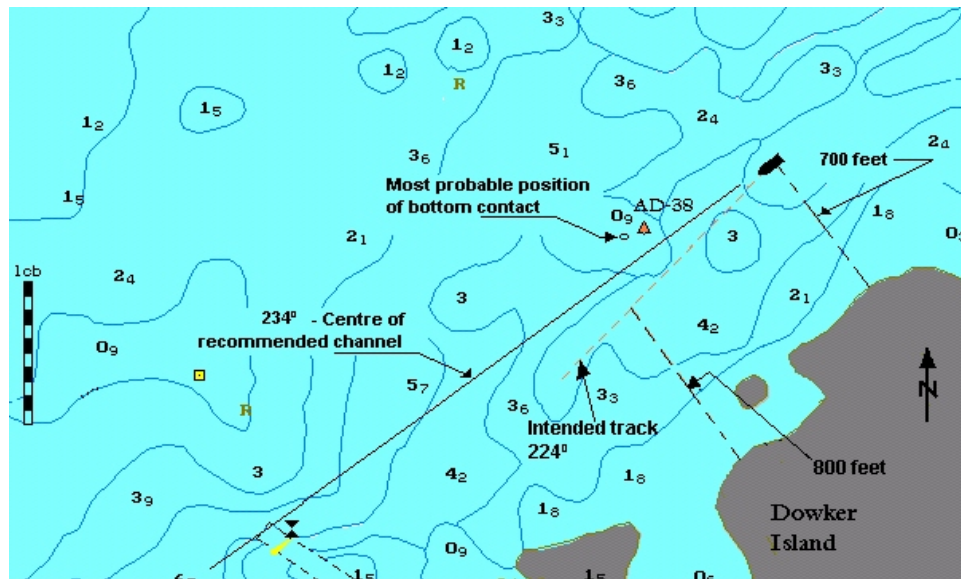
Figure 2

Once abeam the first point at the predetermined distance of 213 m (700 feet), the intended track would have to have been approximately 224° true in order to make the second point at the predetermined distance of 244 m (800 feet) (see Figure 2). A proper passage plan was not being executed by the navigation personnel, and the progress of the vessel was not being plotted on the chart. The vessel was being steered by DGPS and followed a path of 233° (DGPS), very nearly the 234° true that would follow the centre of the recommended channel. This would suggest that the vessel was in fact more to the northwest than the “approximate” position reported by the master.

Scarcely 30 m (100 feet) to the northwest of the “approximate” position given by the master is the 1.83 m (6-foot) depth contour mentioned earlier. The only individual sounding within this depth contour is a 0.91-m (3-foot) sounding 61 m (200 feet) to the northwest of the centre of the recommended channel. While all other depths within this contour are not known precisely, it is known that depths are less than 1.83 m (6 feet) above chart datum. At the time of the incident, the “CANADIAN EMPRESS” was drawing 1.6 m (5 feet 3 inches) aft, and the keel coolers were exceeding the hull by approximately 0.05 m (2 inches).

Given that the damaged keel coolers were covered with a clay-like substance and given the observation by a passenger of the muddied waters astern the “CANADIAN EMPRESS” subsequent to the rumbling sound heard throughout the ship, it may be concluded that the vessel made contact with the bottom. The Canadian Hydrographic Service later sounded the area around the position of the grounding as reported by the master, but no anomaly in depth was found. As illustrated in Figure 2, the vessel was most probably 61 m to 76 m (200 to 250 feet) to the northwest of the reported “approximate” position of the incident and thus inside the 1.83-m (6-foot) depth contour when contact was made with the bottom.

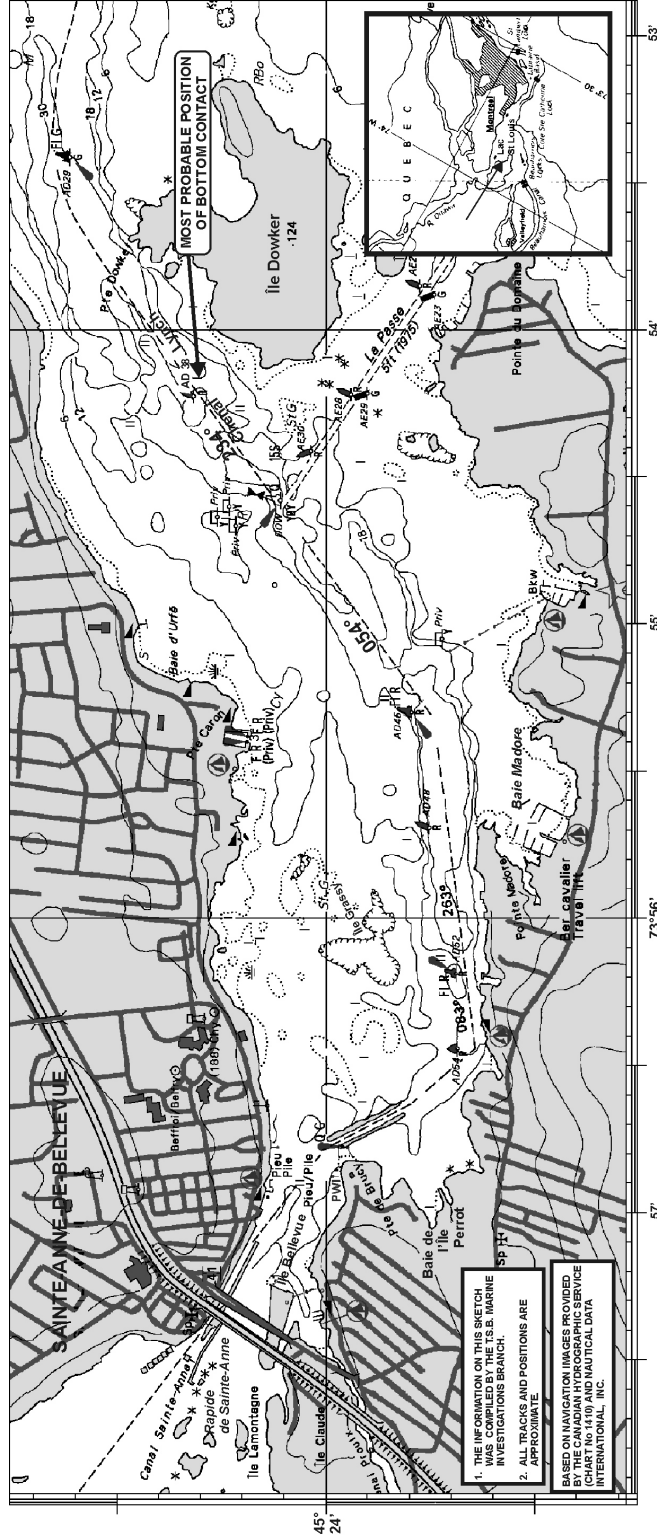
# Appendix A

At approximately 0849, the master was satisfied with the ship's position abeam a small, unnamed point of land on the northwest side of Dowker Island at the predetermined distance of 213 m (700 feet). This put the vessel in the centre of the recommended navigation channel, and the master was now preparing to come abeam the next point of land on Dowker Island at 244 m (800 feet). Before 1996, the centre of the recommended channel was indicated by leading lights at Madore Point, but these lights had since been discontinued. The master and the mate had made numerous trips up and down the river in this area over the years, both before and after the leading lights at Madore Point had been discontinued. (See Appendix A.)

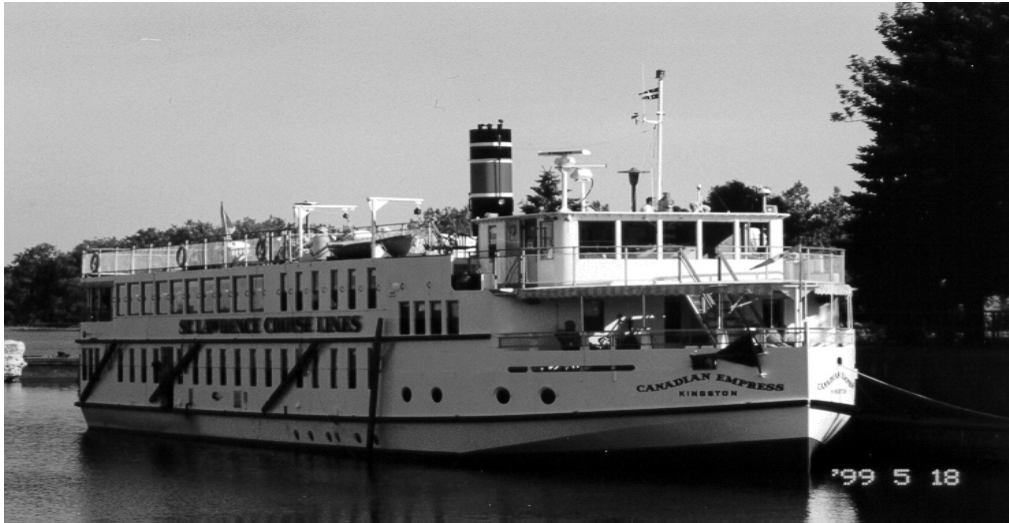
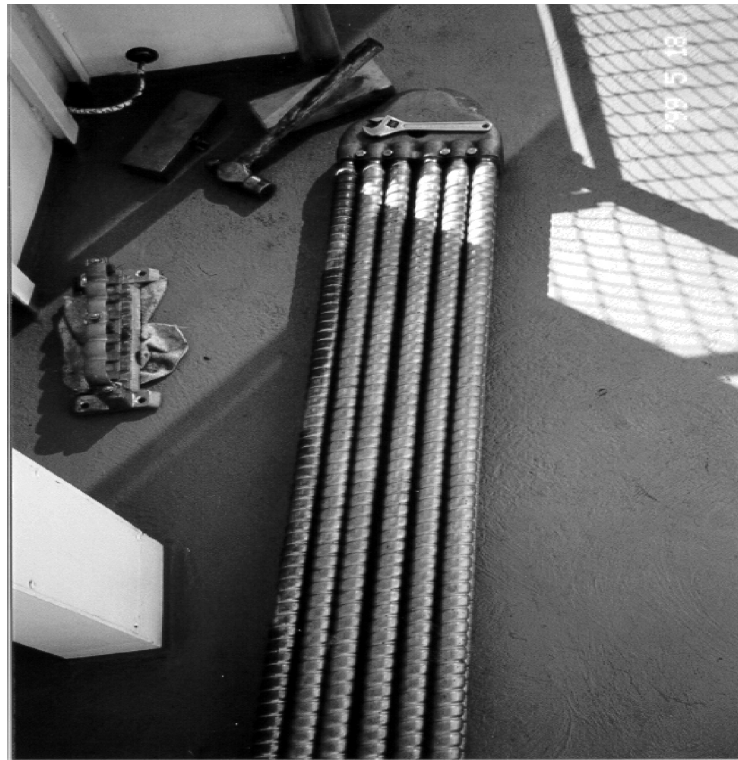
*Appendix B*

The underwater inspection confirmed damage to the starboard-side keel coolers. The damaged keel coolers were removed from the hull by the divers and found to be covered with a clay-like substance. A bypass arrangement in the engine room was installed that allowed cooling of the starboard-side machinery by way of the port-side keel coolers. On 14 May 1999, once the bypass was completed, the vessel continued on her voyage up the Ottawa River without incident.

9. When the damaged keel coolers were removed from the hull, they were found to be covered with a clay-like substance.
10. Both starboard keel coolers were damaged beyond repair due to bottom contact.

**NEW KEEL COOLER ON (DECK)**
